Grout Cracks in WTG Foundation

How to tackle?

NeXHS Renewables Private Limited, Chennai
sudhansu.prusty@nexhs.com

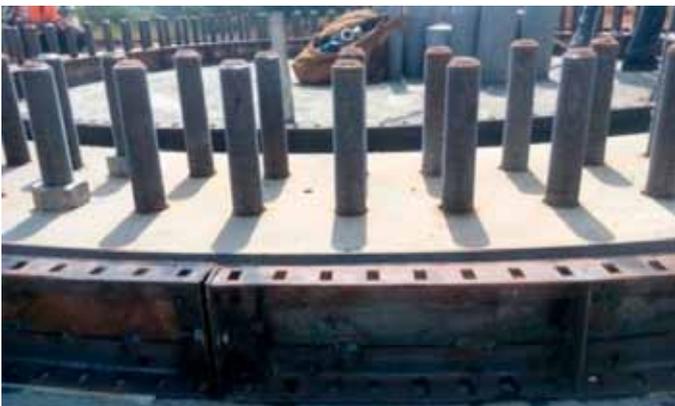
Figure 1:
Formwork for Grouting

1. Selection of suitable formwork material (GI sheet/MS plate). Figure 1 shows the typical formwork using MS plate at a site.
2. Calculation of minimum gap required both inside and outside
3. Height of formwork above the grouting level
4. Ensuring the uniformity of the gap all around
5. Sufficient support to formwork
6. Surface preparation for grouting by suitable methodology
7. Surface treatment before grouting
8. Selection of adhesive bonding agent between concrete surface and grouting surface

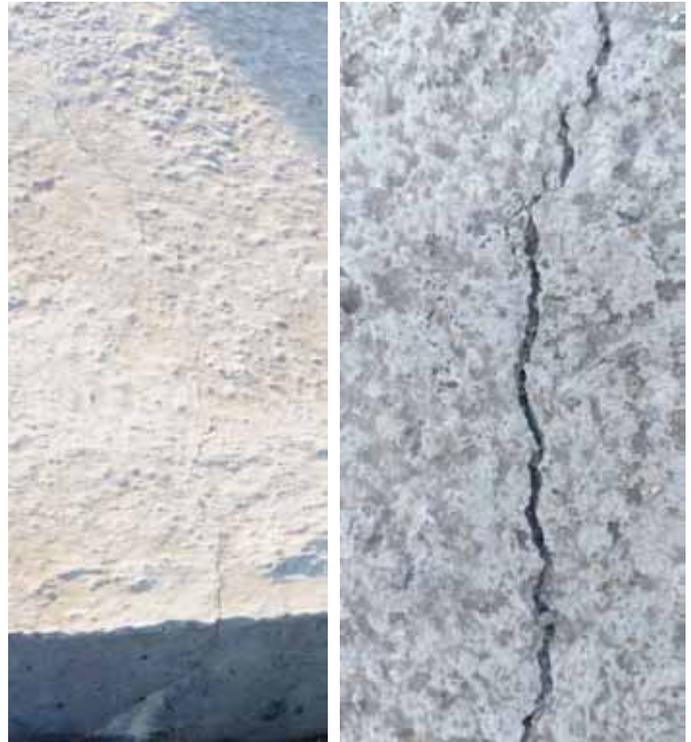
Figure 2:
Radial Cracks on Tower Pedestal – Crack Expanded

the construction and installation of projects and often result in deviations. Such field deviations lead to cracking in grouts in common as can be seen in Figure 2. Further, the types of cracks in grouts as experienced by us while executing and during the life of the project in the field are discussed in the following sections. The process of grouting at site is demonstrated in Figures 3 and 4.

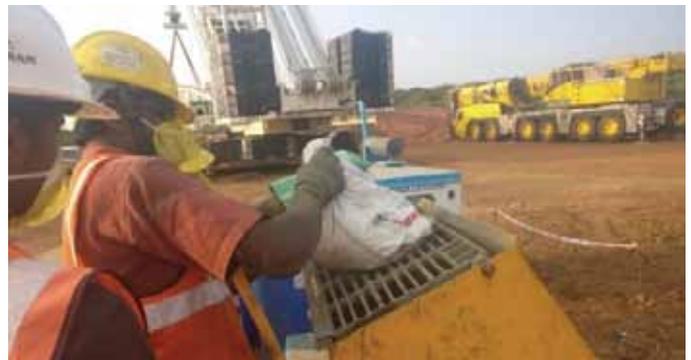
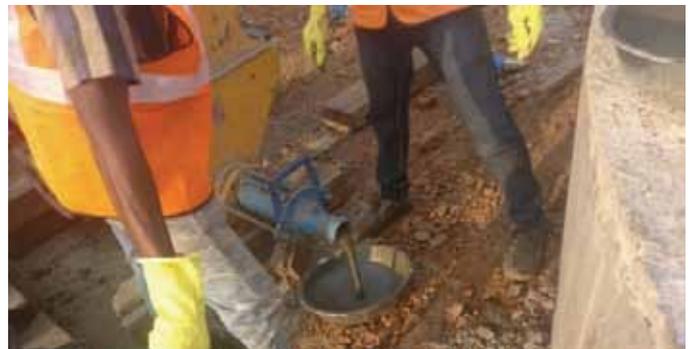
Figure 3:
Process of grouting at site

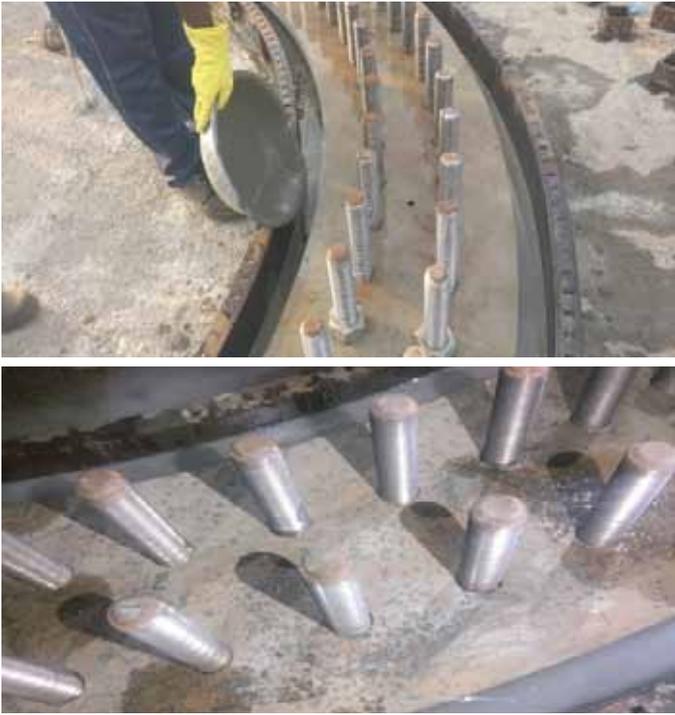
Figure 4:
While and after grouting

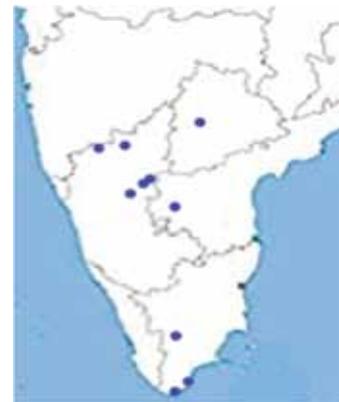
Figure 5:
Location of Wind Farms (■)

Based on the pattern of failures from a survey on wind farms located in southern part of India by the authors, it is observed that in each wind farm, there are issues related to grout to the extent of 3% to 5% after commissioning. Figure 5 shows the location of wind farms considered for the selected study. Figure 6 shows the representative number of wind turbine foundations affected by the issues related to grout.

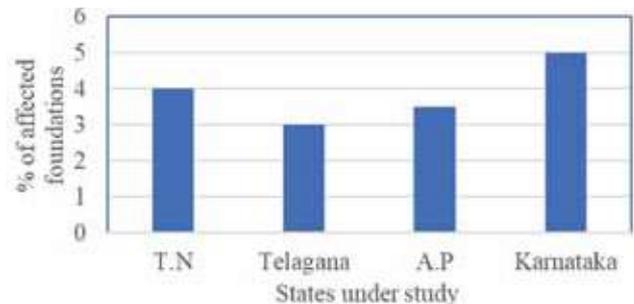
Figure 6:
Foundations Affected by Issues Related to Grout
